RESERVE STUDY UPDATE

Princeton Square Homeowners Association
2660 Princeton Trace
Cumming, GA 30041

Project No. 14-5929

February 2, 2015

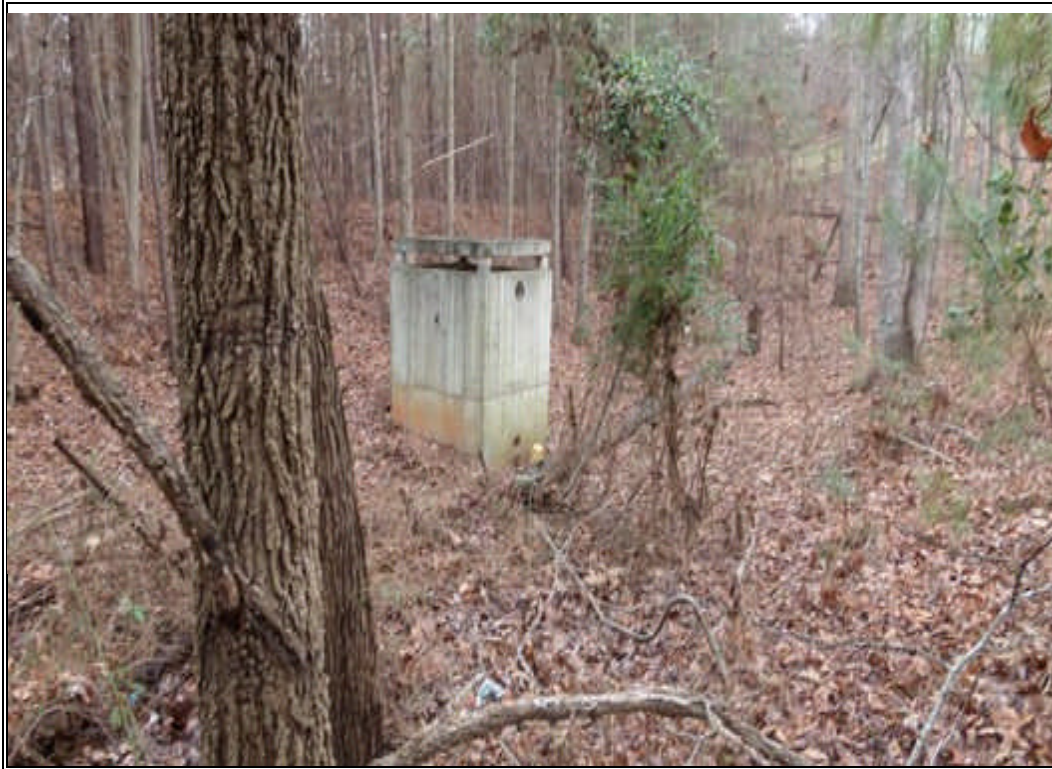
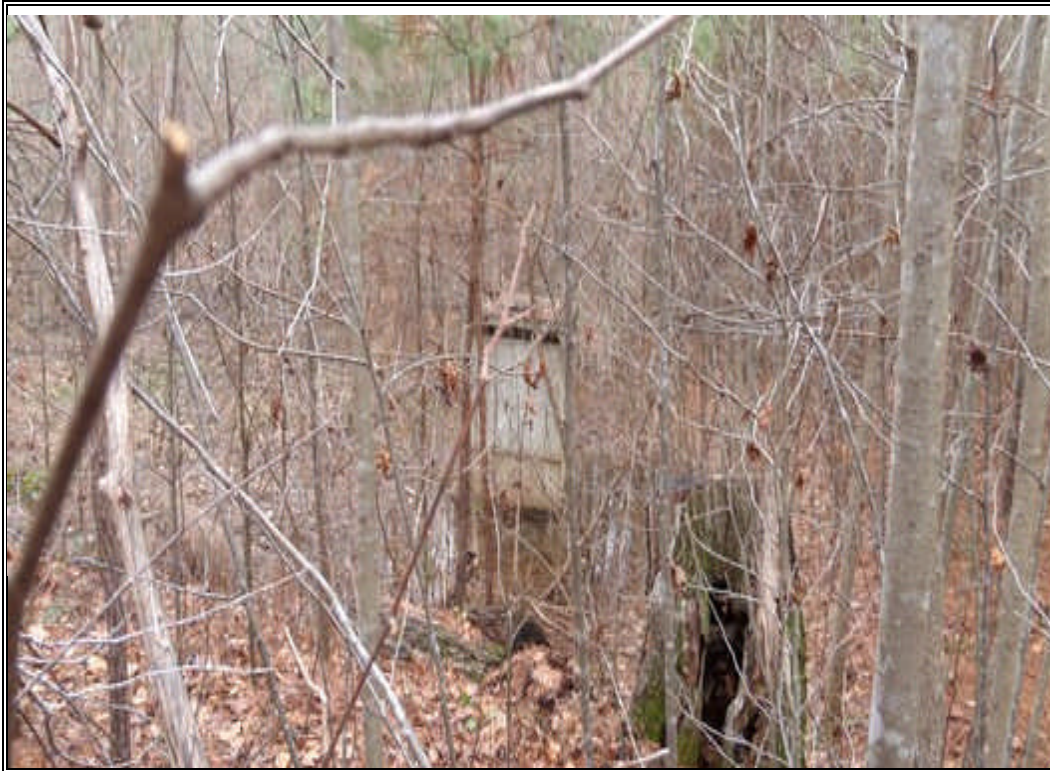
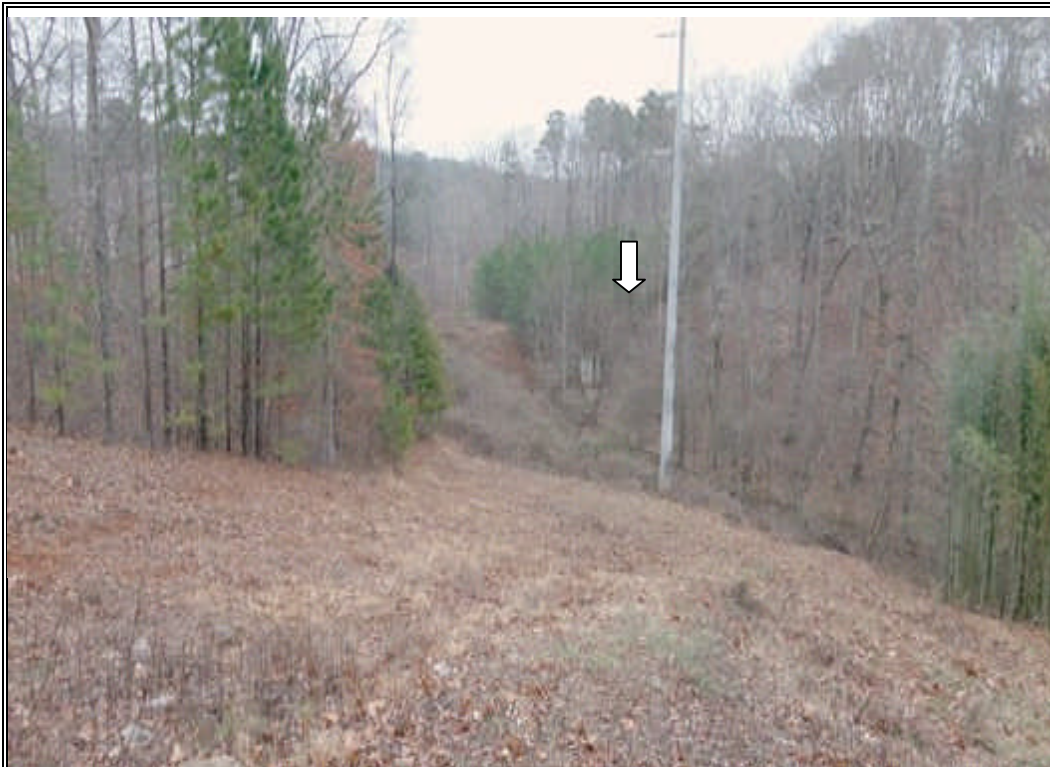
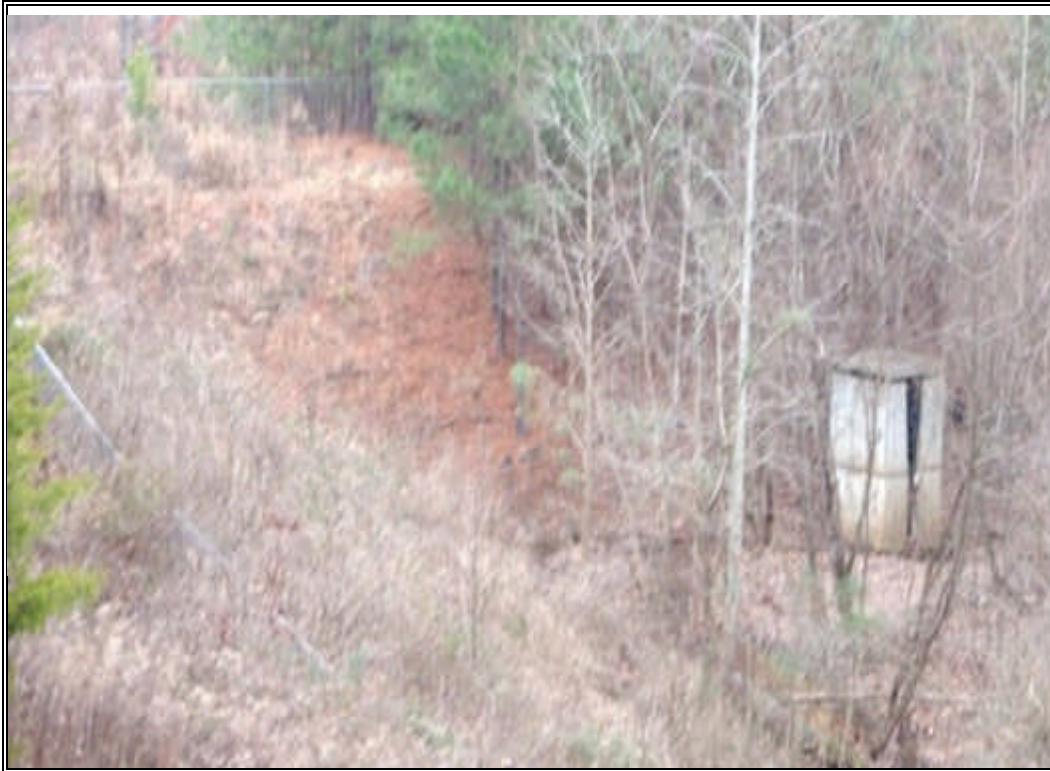
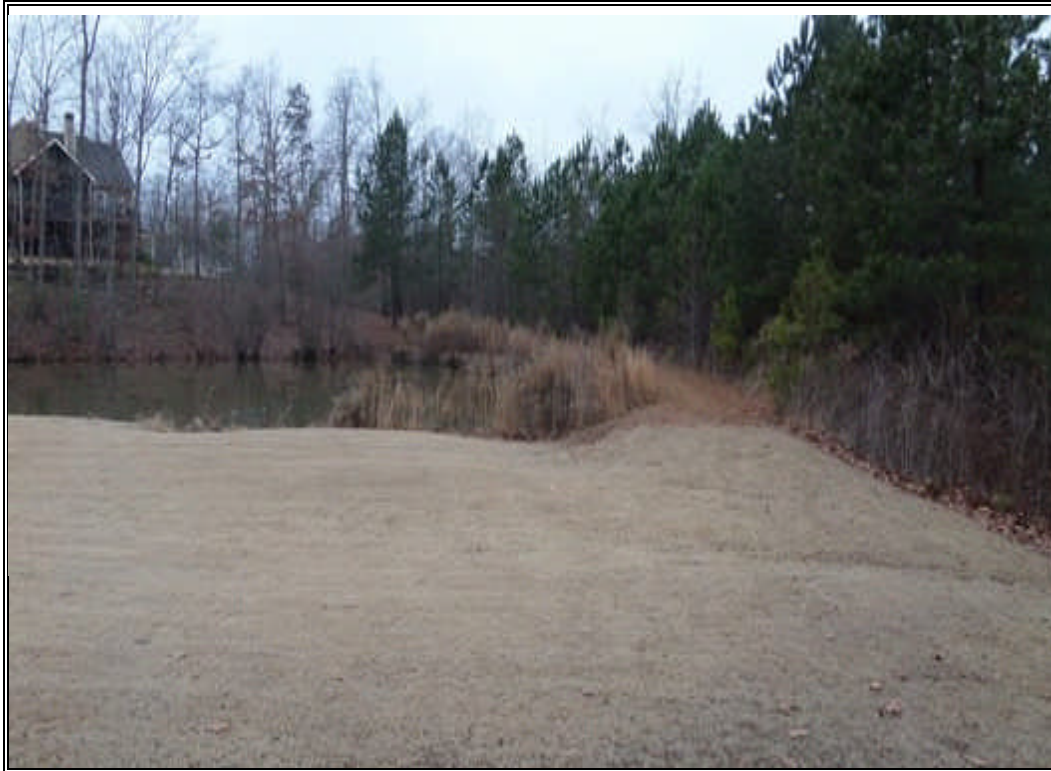
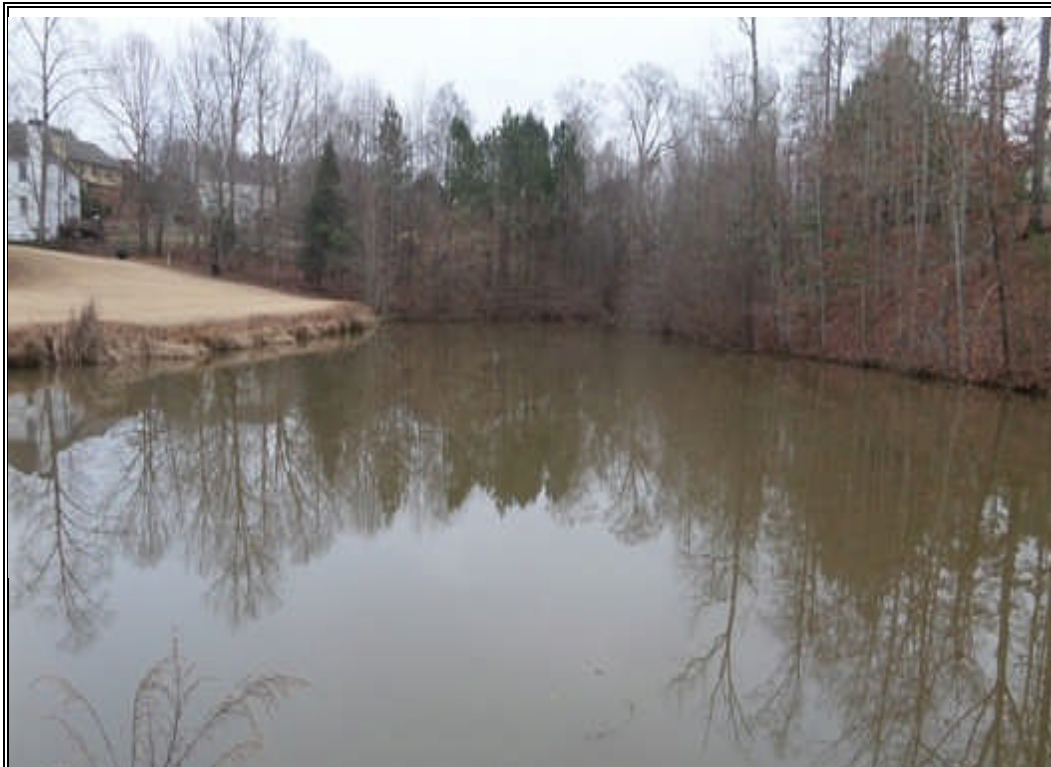
The earth dam surface should be maintained by removing excess vegetation and trees. Periodic maintenance of the retention/detention areas is needed. The outlet structures must be maintained in an operational condition. Some of the outlet structure manholes appeared to be missing. Some of the detention areas were not visible for inspection and access to other areas was limited. Where visible, the outlet structures appeared to be in satisfactory condition. See photos 4 through 12 and the stormwater map in Appendix C.

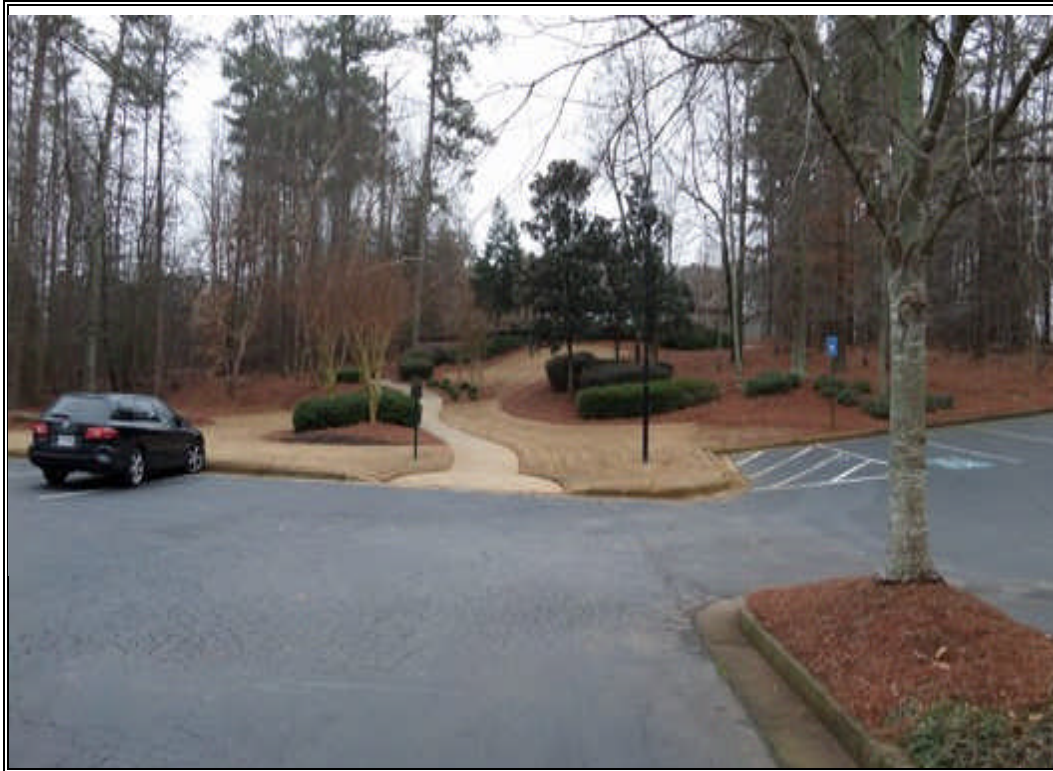
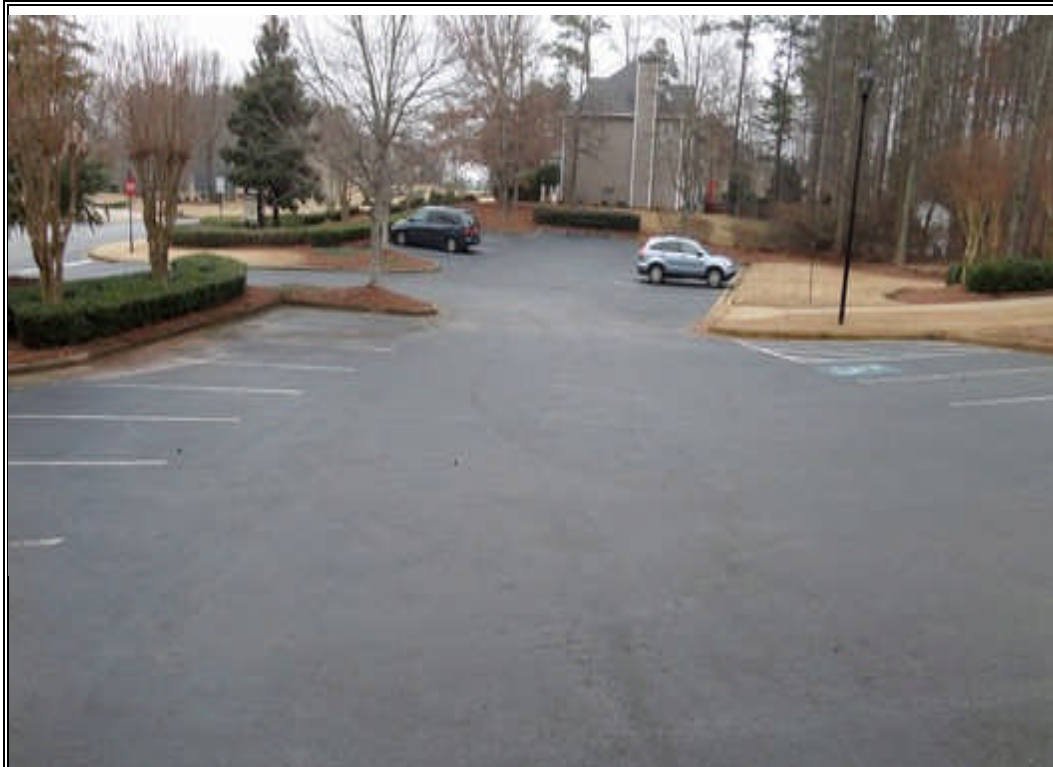
The parking lot striping is faded. Fatigue failure (alligatored pavement) was observed at several locations in the lot (photos 15 & 16).

Description:
Amenity parking
lot

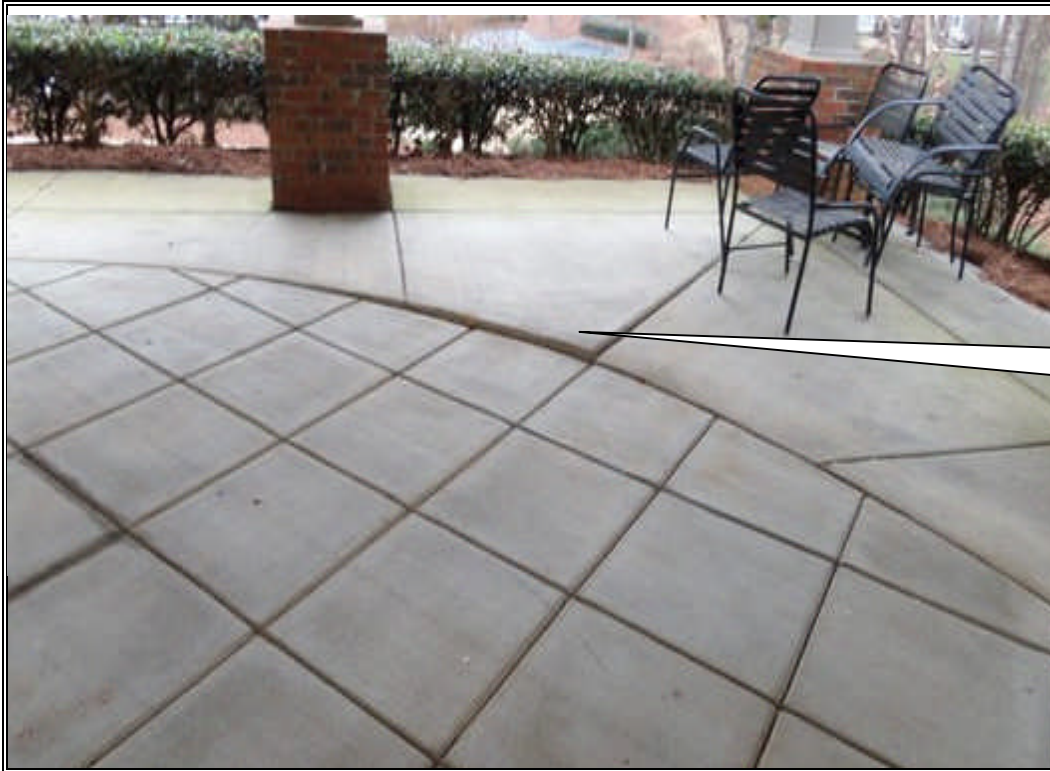
Photo Number
19

There is a raised pavement area in the pavilion which is a trip hazard (photo 19). Some sections of the sidewalk are raised and are a trip hazard (photo 37). Repairs will be needed by grinding down the trip hazard or replacement of the pavement section.

Description:
Pavilion floor

Raised
pavement

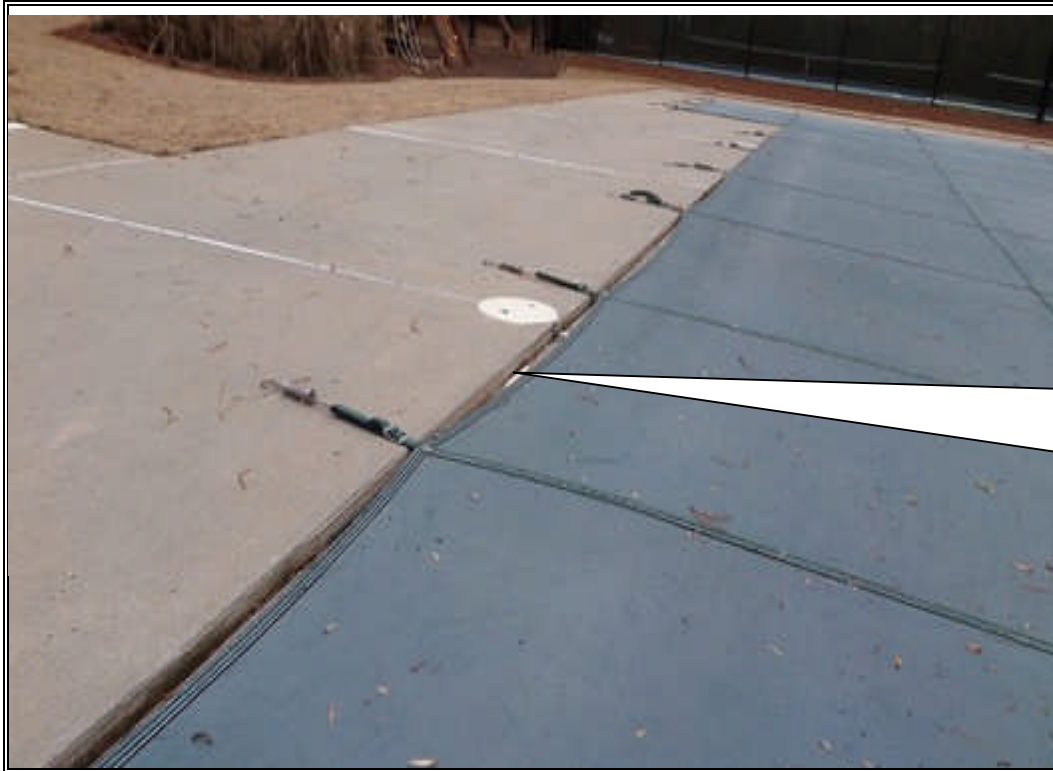
Photo Number
25

There is a significant difference in elevation between the edge of the Adult pool coping and the pool deck pavement (photo 25). This elevation difference varies around the pool at the coping. It appears that the pool may have settled or the pavement has risen up. This condition needs further evaluation to determine the exact cause for the differential movement. Once the cause is determined repairs will be needed.

Description:
Adult pool

Elevation
difference
between deck
and pool edge
coping

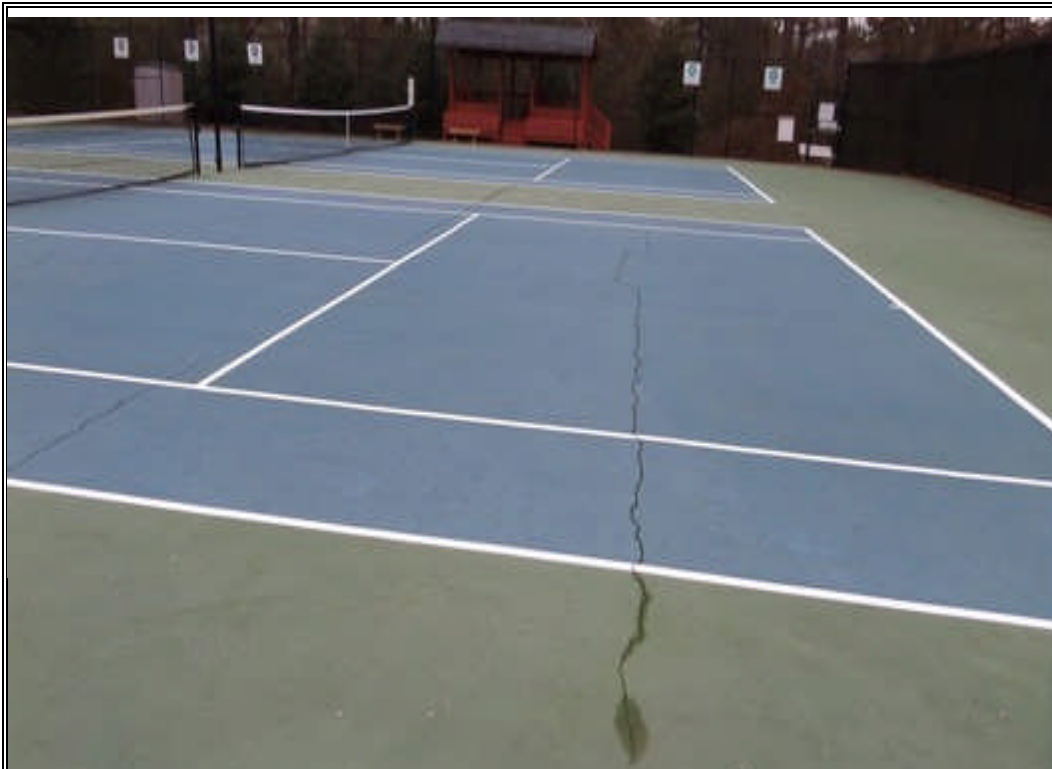
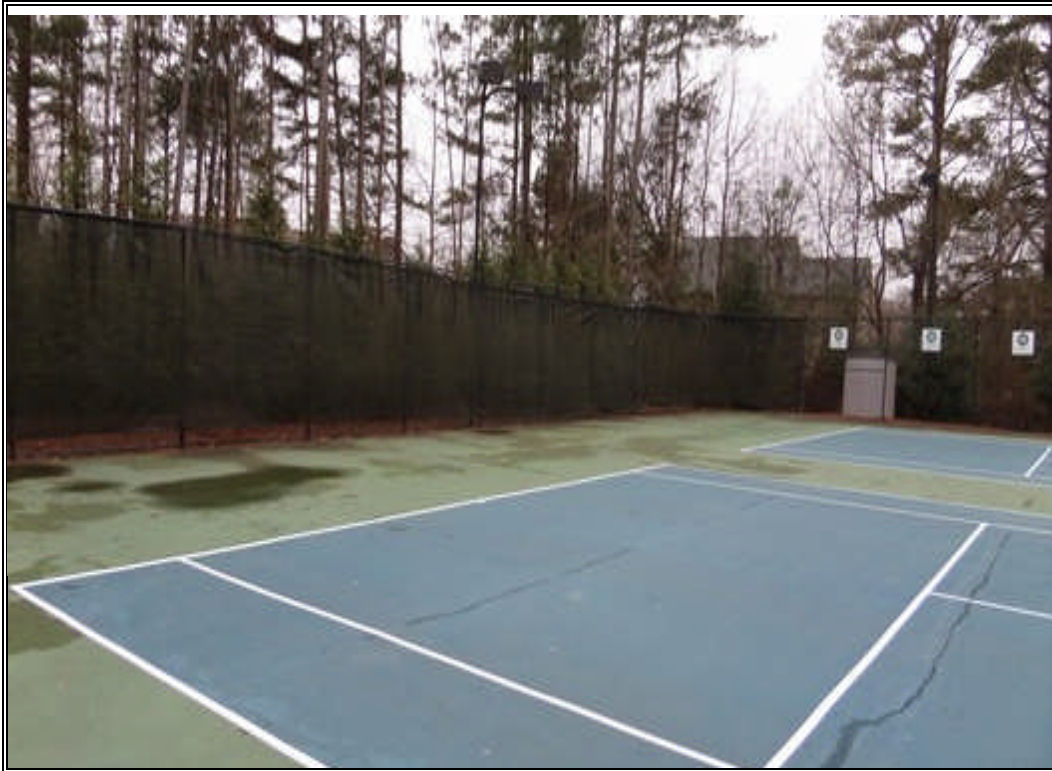
There are cracks in the tennis courts and water appears to accumulate on its surface (photos 28 & 29). The cracks should be repaired at the next resurfacing of the courts.

Description:
Tennis courts

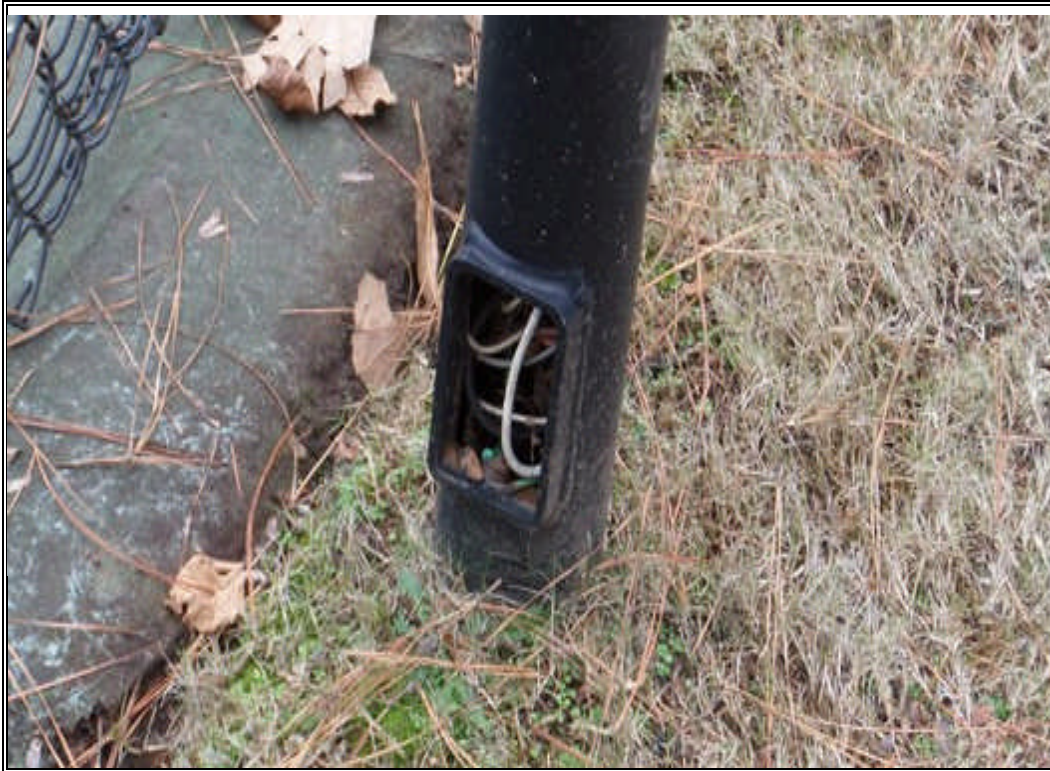
Photo Number
31

Several junction boxes at the tennis court light poles are open (photo 31). This is a hazard especially to children. Proper covers should be installed. The electrical receptacle at the tennis viewing area is not accessible (photo 33).

Description:
Open junction box
at tennis court
lightpole

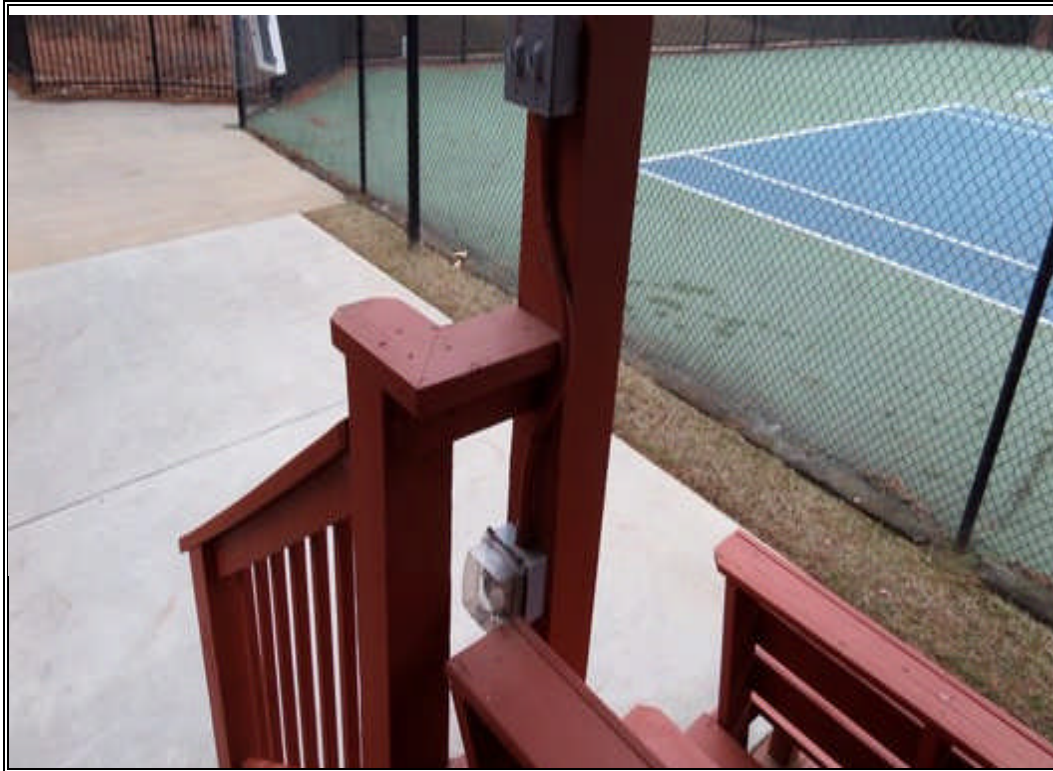
Photo Number
33

Description:
Inaccessible
electrical
receptacle at tennis
stand

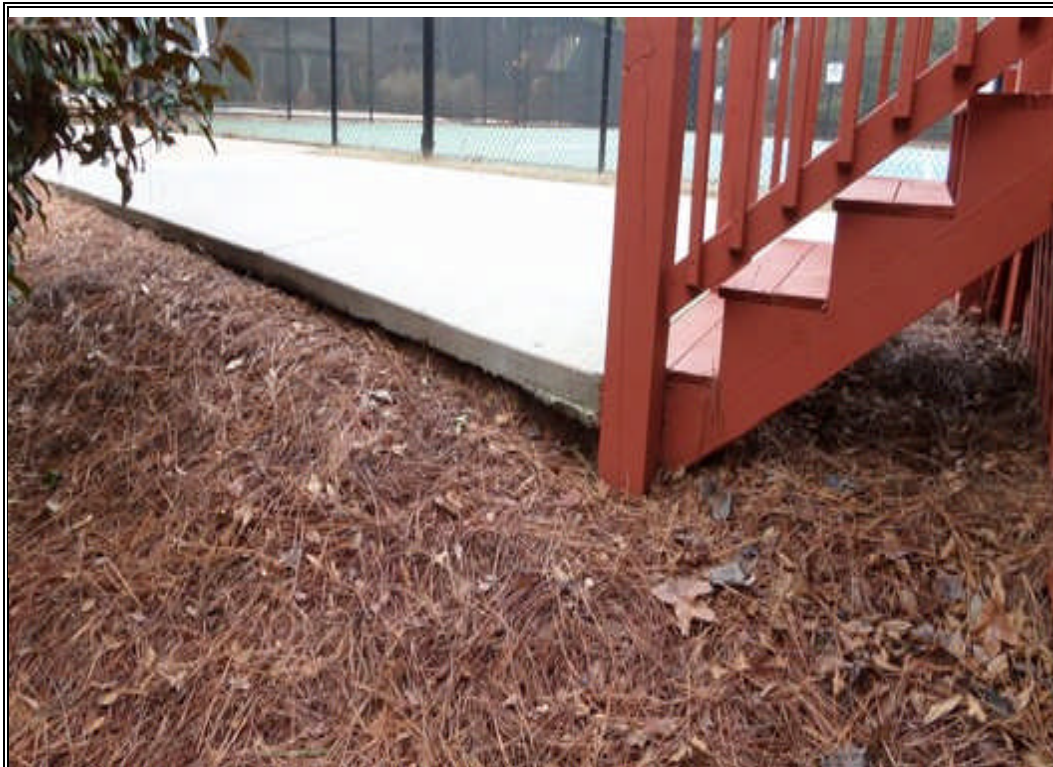
Photo Number
34

The sidewalk at the tennis viewing area is somewhat undermined (photo 34). The sidewalk may crack if the void is not filled for proper support.

Description:
Sidewalk at tennis
viewing stand

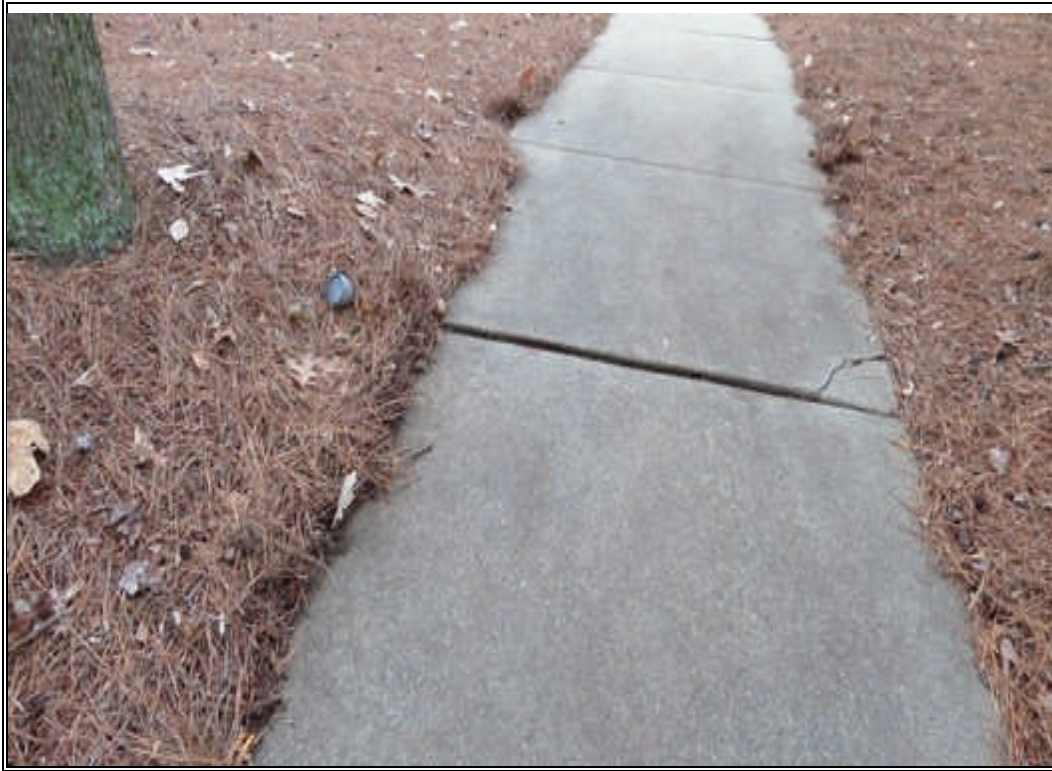
Photo Number
37

Description:
Sidewalk – trip
hazard

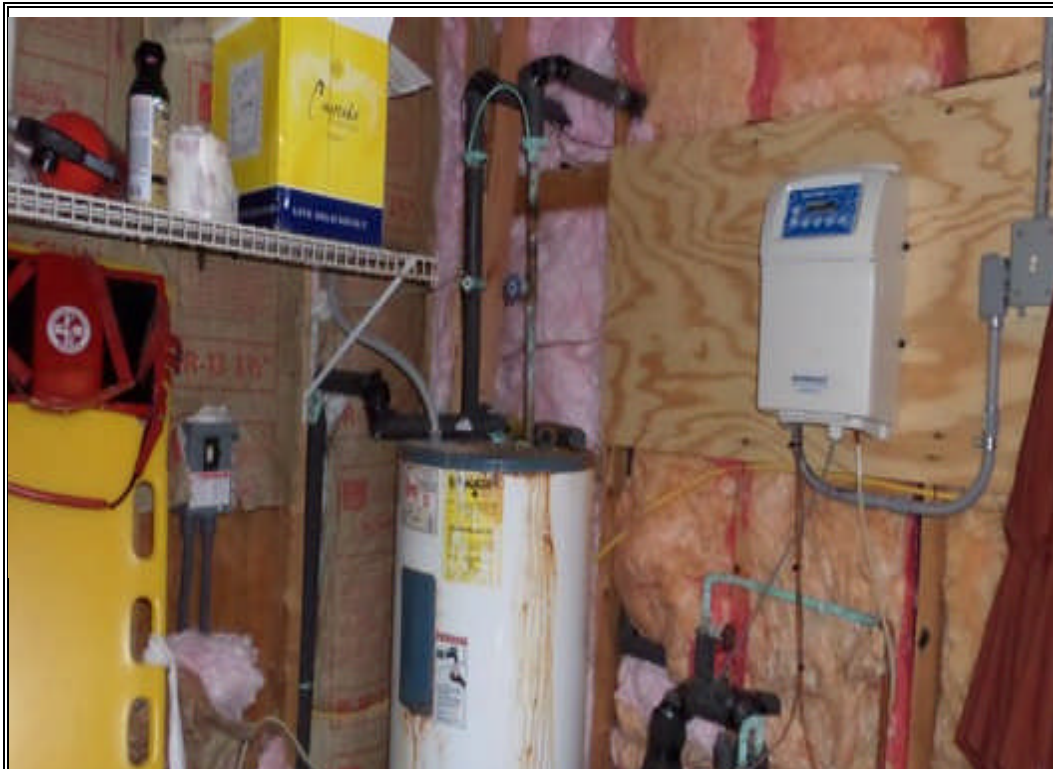
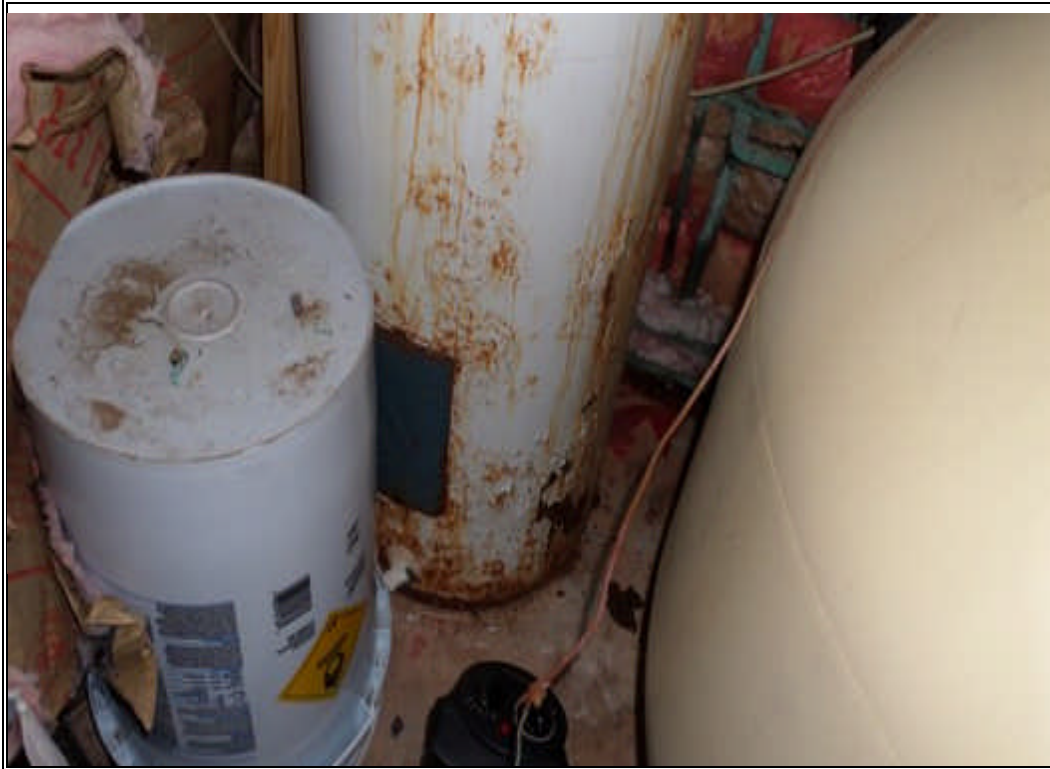
The water heater in the pool equipment room is heavily rusted and in poor condition (photos 40 & 41). It will probably need replacement in the near future.

Description:
Water heater
